WILD TROUT TRUST

## **River Chelt**

Guardians of the River Chelt

Gloucestershire

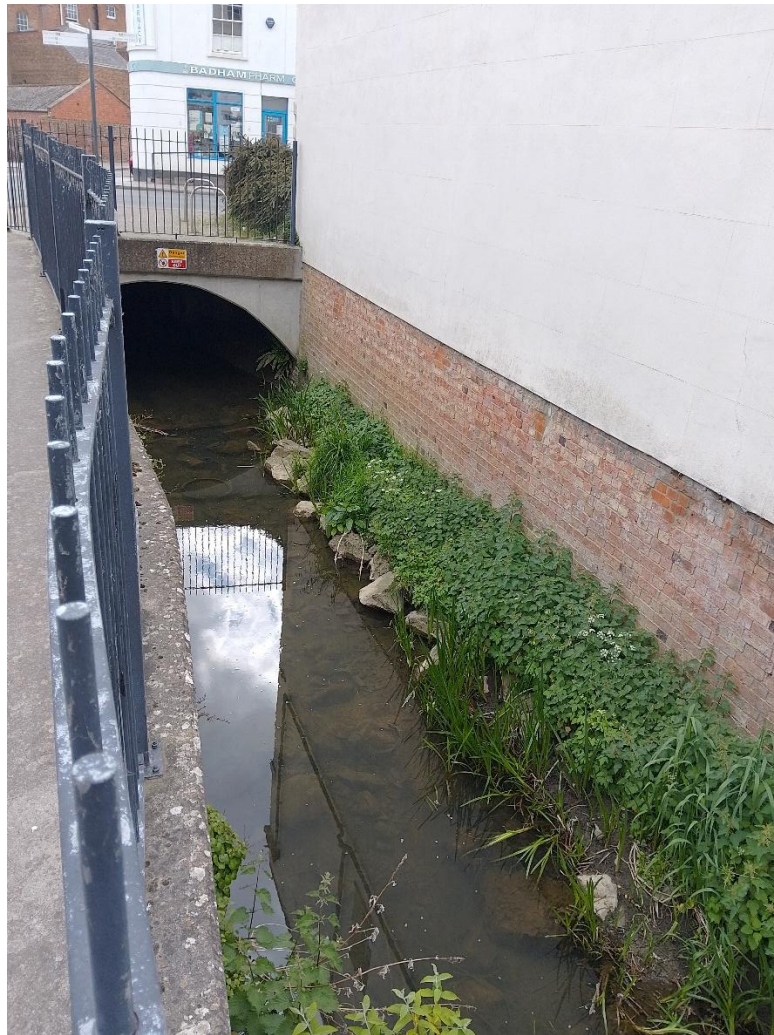
*Photo 1 The start of the survey section by the Bayshill Pub. The Chelt resurfaces after several hundred metres of being buried under the town. The river is heavily modified, constrained by high artificial banks in a straight channel. The larger rubble in the bed will offer some physical habitat for fish and aquatic invertebrates, the accumulation of sediment on the left bank is allowing some vegetation to take hold. The emergent and trailing leaves provide a small amount of natural habitat structure as well.*

At the start of the reach inspected, the Chelt emerges from a significant length of culverting (c. 400m) where it has been incarcerated under urban development (Photo 1). This is the first example seen in the Chelt of serious fragmentation of river habitats and connectivity for fish populations. Culverts create a specific issue for fish, through engineered flows in smooth sided channels being too fast for swimming abilities when water levels rise, or levels too shallow for passage at times of low flow. Long culverts become very dark inside, demotivating some fish to pass through (especially those reliant on visual ability) due to wariness of potential predators. Passage issues can be remediated by changing flow conditions in the culvert, by introducing a rougher channel (larger bed material) or installing low baffles though the bed of the culvert to raise water levels at low flow and reduce high flow velocities (Figure 2 and Figure 3). Innovative solutions to light the interior of culverts have been previously used in river restoration projects, encouraging fish to pass through the feature. Any action to manage low flow in the culverts would need to go through appropriate regulatory channels and flood modelling to ensure no additional impact was made on flood water levels, beyond the existing influence of the culverts themselves. Overly straight channels hemmed in by smooth concrete, move flood water very quickly along the river channel. The restriction (or 'throttle') created by the culvert then backs water up as it can only convey a certain amount of water at a time. All fish species require free access to different parts of the catchment for feeding, reproduction and refuge through the year. Anything that inhibits this movement – a barrier like a culvert or weir – will impact fish ability to complete life cycle or numbers of fish present

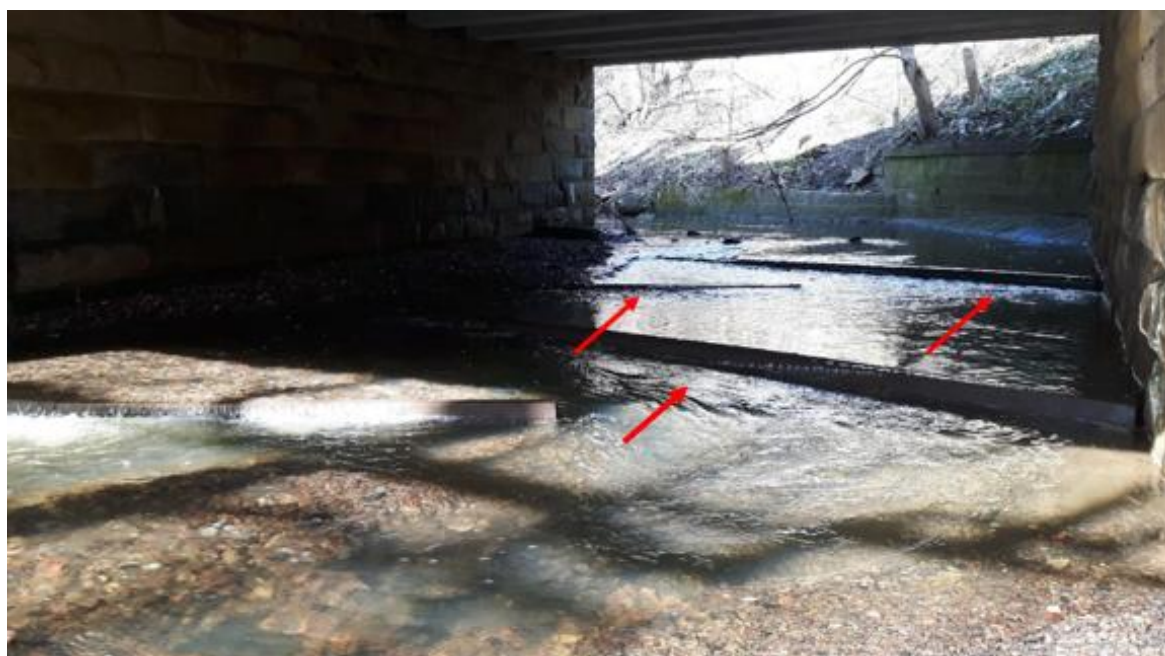
Figure 5 Alternatively, a series of low baffles can be installed in a culvert to create depth and flow conditions allowing fish to pass through at low flows (red arrows highlight the baffles)

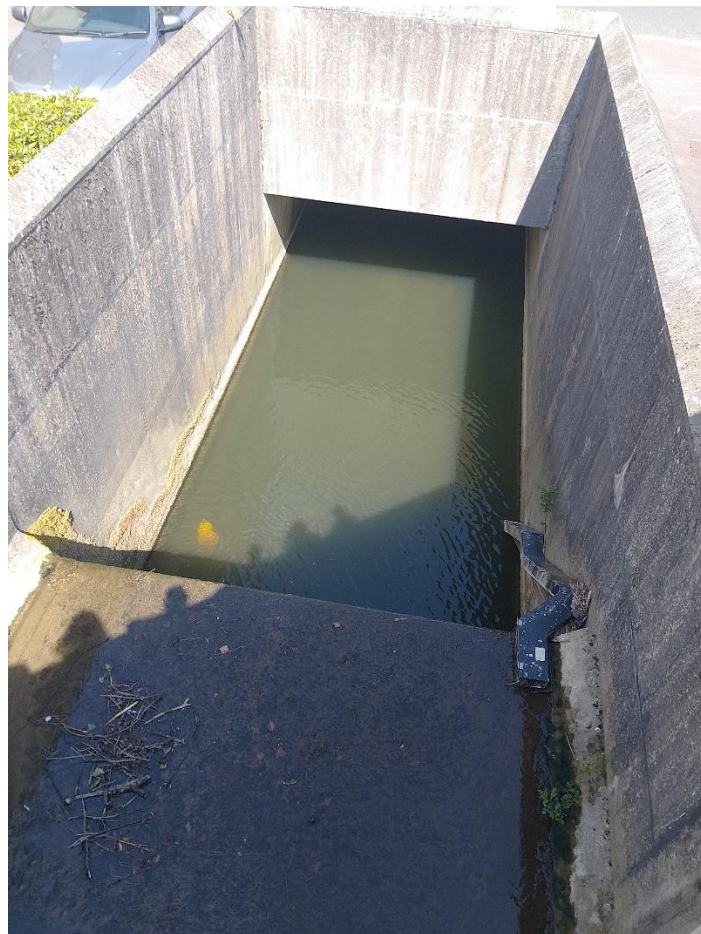
*Photo 12 The large vertical drop and next culvert – right hand channel. An elver pass has been installed to the side of this.*

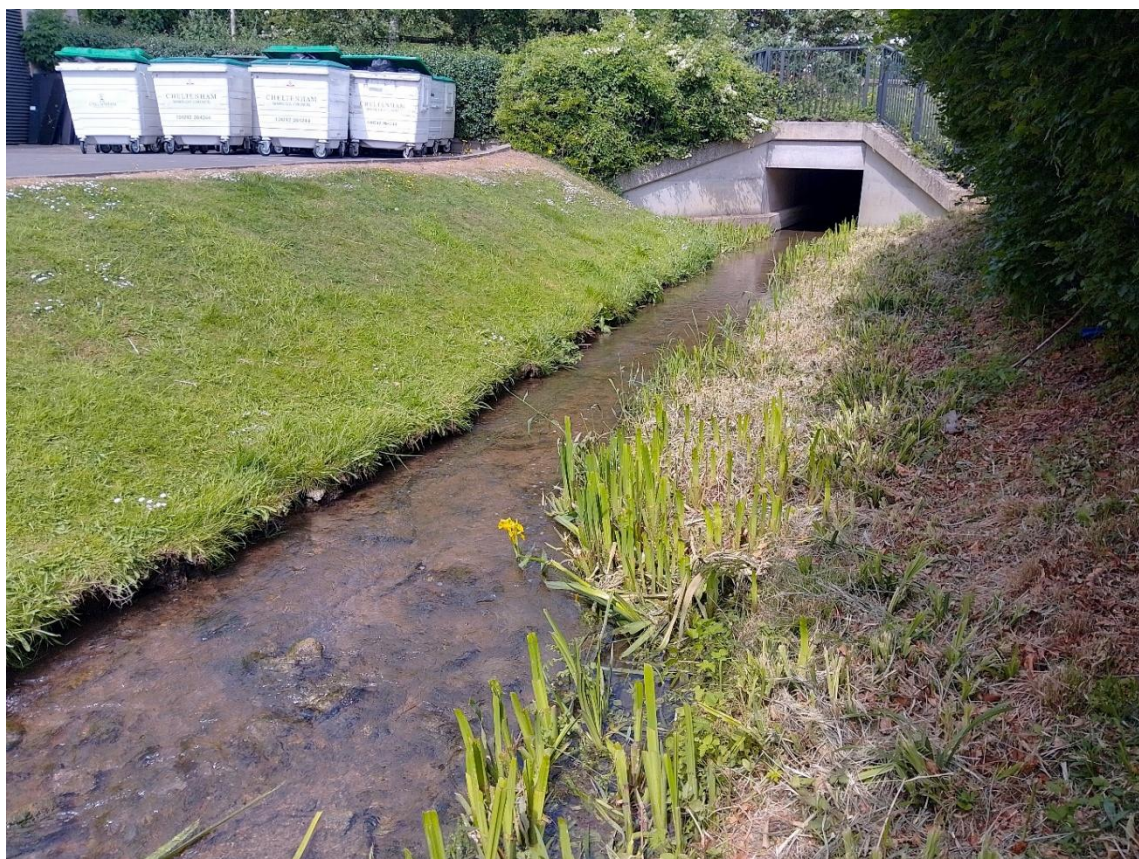
*Photo 14 The short section of watercourse past St James Walk Flats, before it is culverted under Honeybourne Way. The emergent marginal vegetation should be*

*allowed to develop to provide a little habitat here; cutting it does little to reduce flood risk, compared to the adjacent hedge or huge throttle effect of the culvert entrance which are potentially far bigger issues!*

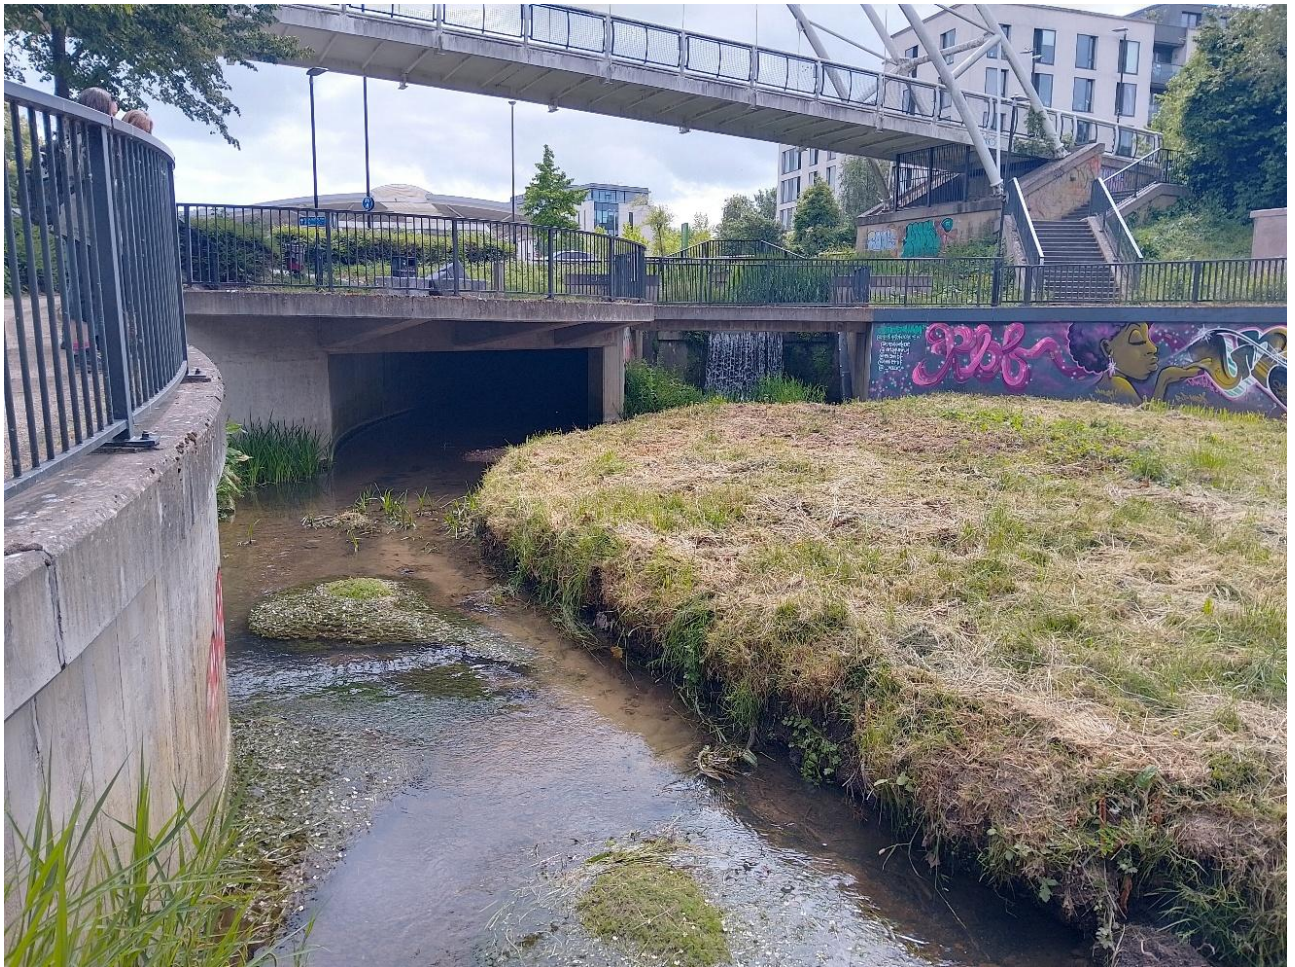
*Photo 16 Looking back upstream at the two connectivity issues fish face in this section of the Chelt – a massive culvert or a vertical weir. It is unsurprising eels are not well represented in fish surveys upstream, as they can't easily get there, despite the elver passes. Should pollution events occur, and fish populations are lost upstream, it will be very difficult for natural recolonisation to occur. The Chelt regains a little dignity here, escaping completely concrete lined channels. Despite the LHB being heavily trimmed, the slightly undercut bank and remnants of vegetation trailing in the water afford some refuge to fish and invertebrates. Submerged aquatic plant life starts to proliferate – water crowfoot (*Ranunculus* sp.). This is a very beneficial species and provides habitat for a great range of insect life, excellent cover for all fish species and constrains the channel to create positively energised flow diversity amongst its submerged clumps. This in turn drives a plethora of habitat niches for aquatic species to exploit. Lowering all of the grassed bank area would allow space for moving the channel away from the concrete retaining wall and provide a large area of additional flood water storage through a better-connected floodplain area.*

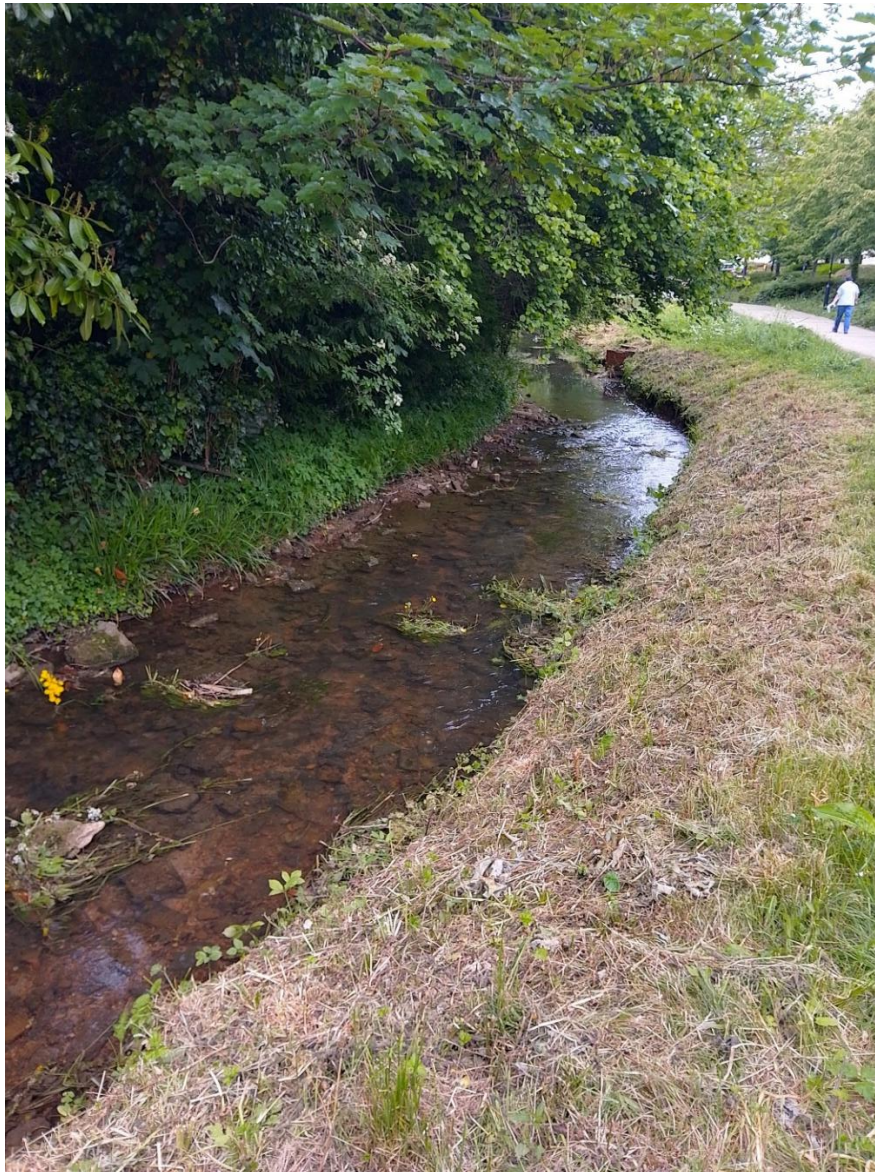
*Photo 17 The Chelt along Honeybourne Way (51.903077 , -2.0873508). Straight and within a classic flood engineered trapezoidal channel shape. Due to lack of natural sediment supply, the substrate is mostly man-made materials but will possibly function with the same effect as larger cobbles and boulders found naturally in streams. Trout, bullheads and all aquatic invertebrates will use the structure as key habitat in this section. Leaf litter from the adjacent trees will provide basal resources for shredding and grazing aquatic invertebrate groups.*

The remainder of the Chelt down to the Gloucester Road is straightened and modified. Although within a small 'green corridor', the Chelt now has housing adjacent to the left-hand bank, a footpath and key access road (Honeybourne Way) above the right-hand bank. The left-hand bank is wooded at the start of this reach, the grassland on the banks between the footpath and housing is heavily trimmed everywhere else, again in the interest of reducing flood risk (Photo 17).

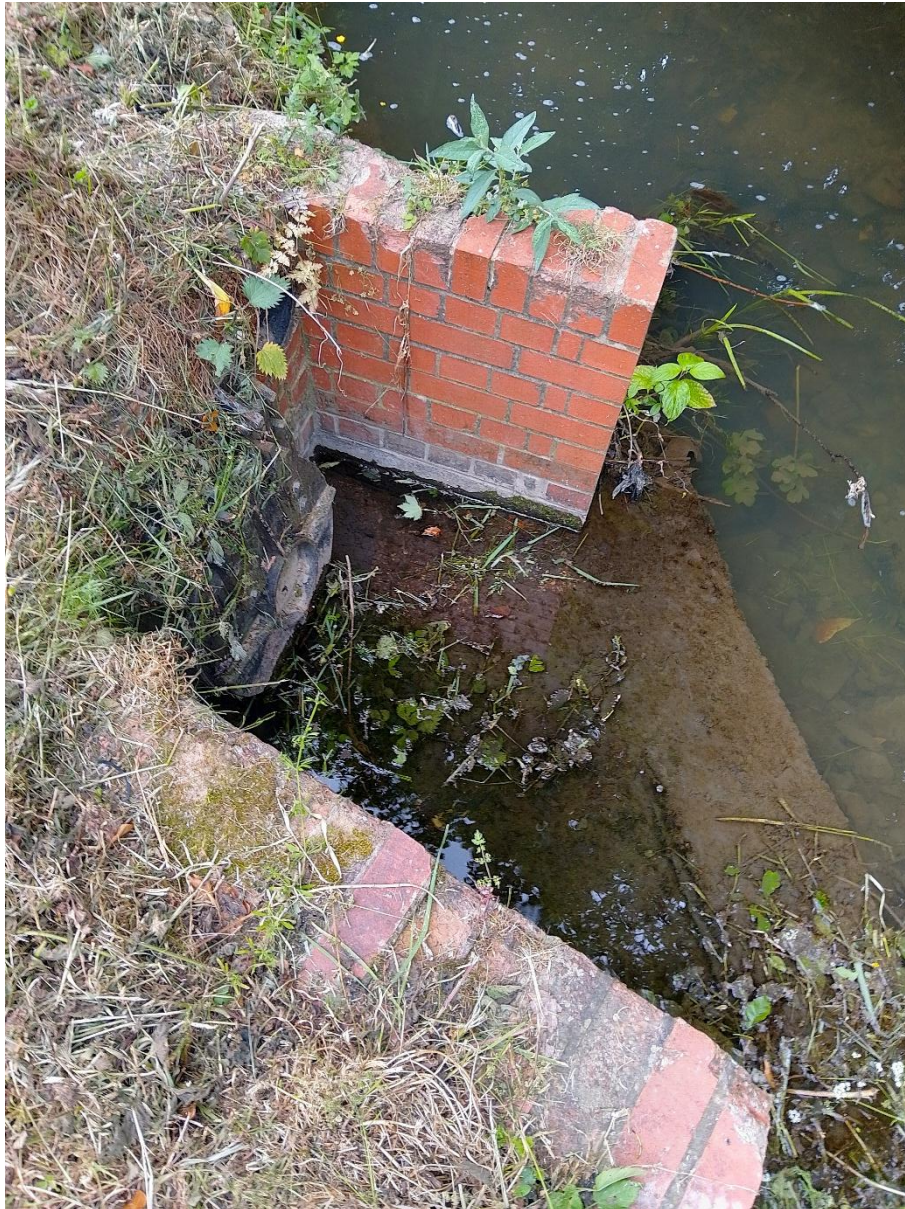
*Photo 18. One of two adjacent storm overflow drains (51.903289 , -2.0874793). What gets discharged to the watercourse from these drains is always a big concern. Obtaining a services map of pipework to review the likely inputs will help understand water quality impacts to the Chelt. GORC can also actively monitor upstream and downstream during periods the pipe is running. Concerns would be contents of road run off (microplastics and pollutants) and misconnections in residential properties (washing machine phosphate input). Mapping features like this and engaging the Council may provide opportunity to break these out (space provided) and run through an urban sustainable drainage system feature (SUDs – e.g. swales, retention pools etc) to allow the water to settle out fine sediment and contaminants a little before reaching the river. Examples such as the 'Outfall Safari' highlight where community groups have mapped issues before: <https://www.southeastriverstrust.org/projects/outfall-safaris>*

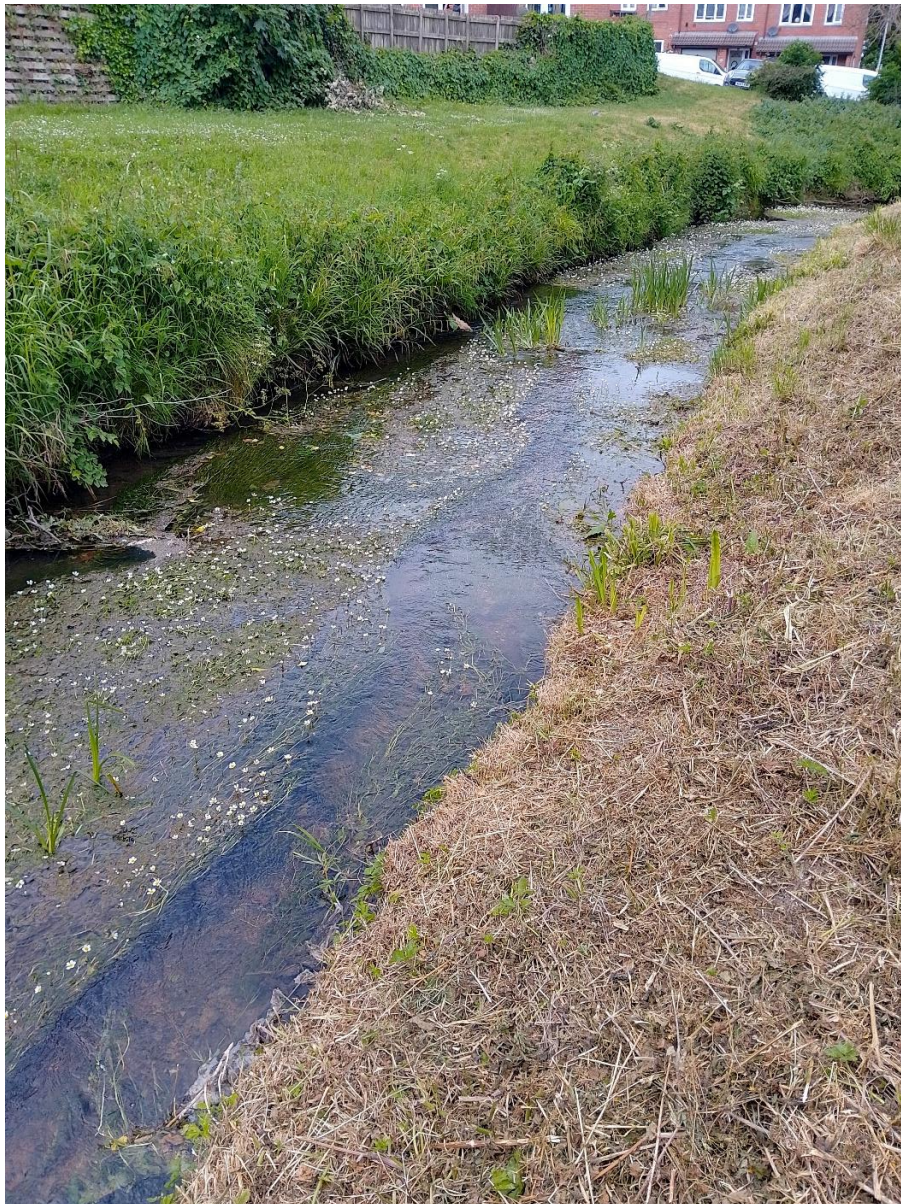
*Photo 20 The final section reviewed, running down to the Gloucester Road. Nice in channel plant growth is present in between the modified banks and channel.*

The final section of watercourse reviewed on the day had open grassy banks on both sides. The grass has been heavily strimmed, limiting habitat value. With less tree shade here, in-channel plant growth is now much more prolific, with some excellent *Ranunculus* growth mitigating the lack of habitat in the channel and margins of the high banks (Photo 20), although only during the summer. *Ranunculus* can exert a strong, beneficial influence on flows, by narrowing the channel to speed flow up between clumps of plant growth (and keep the riverbed clean of silt) and slowing flow down

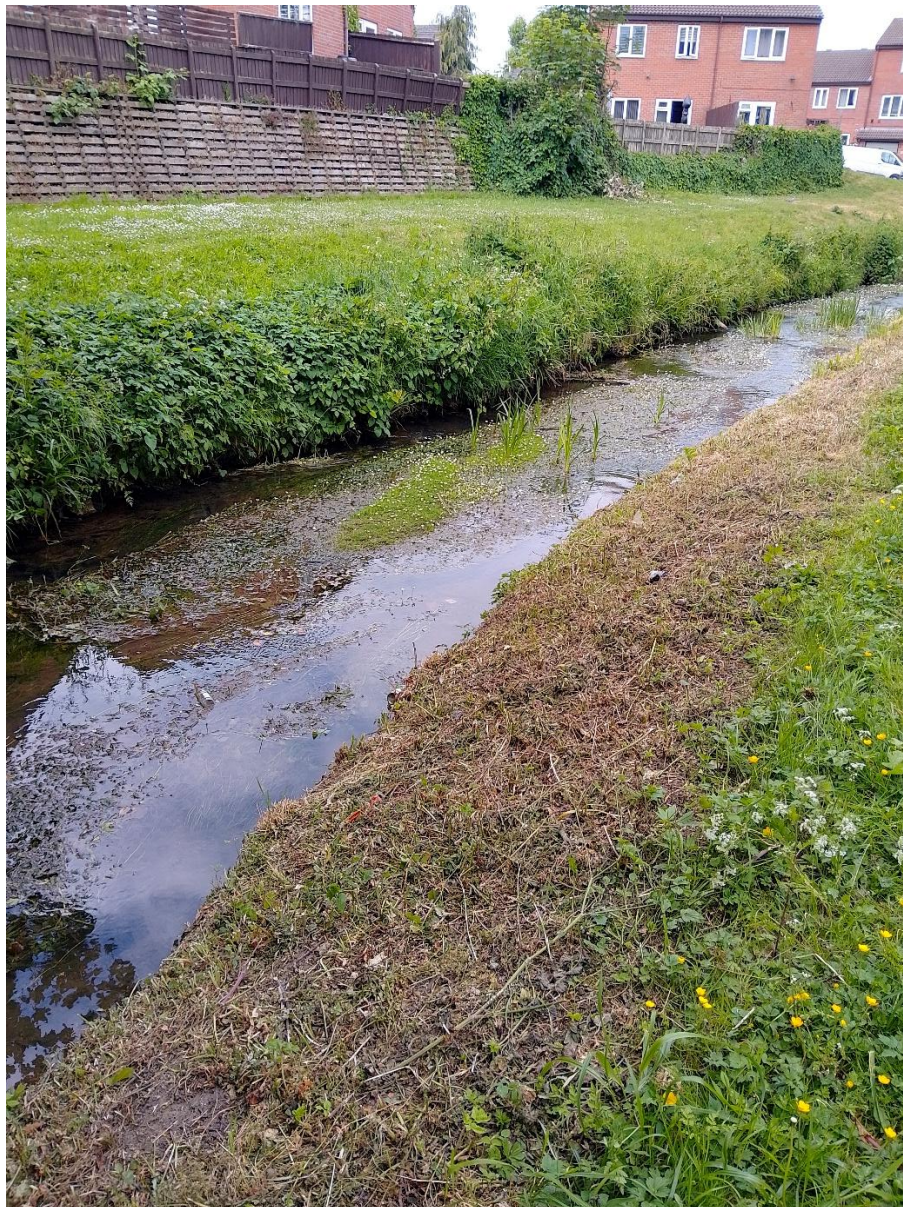
*Photo 21 Removing a large amount of the bankside material here would increase flood water storage capacity, while also giving an opportunity to lower bank heights, re-meander the watercourse and create bed level diversity and*

*subsequent variety in flow. It would also provide an opportunity to reinstate some natural and local material in the riverbed, especially gravel and pebble sized substrates for trout spawning. Giving the watercourse more space by regrading banks could offset allowing natural habitat features to evolve flood capacity wise. Leaving the water crowfoot and allowing a small marginal fringe of vegetation to develop will provide a huge boost to both aquatic wildlife and general insect life (especially pollinators) – equally important to local bird and bat food webs.*

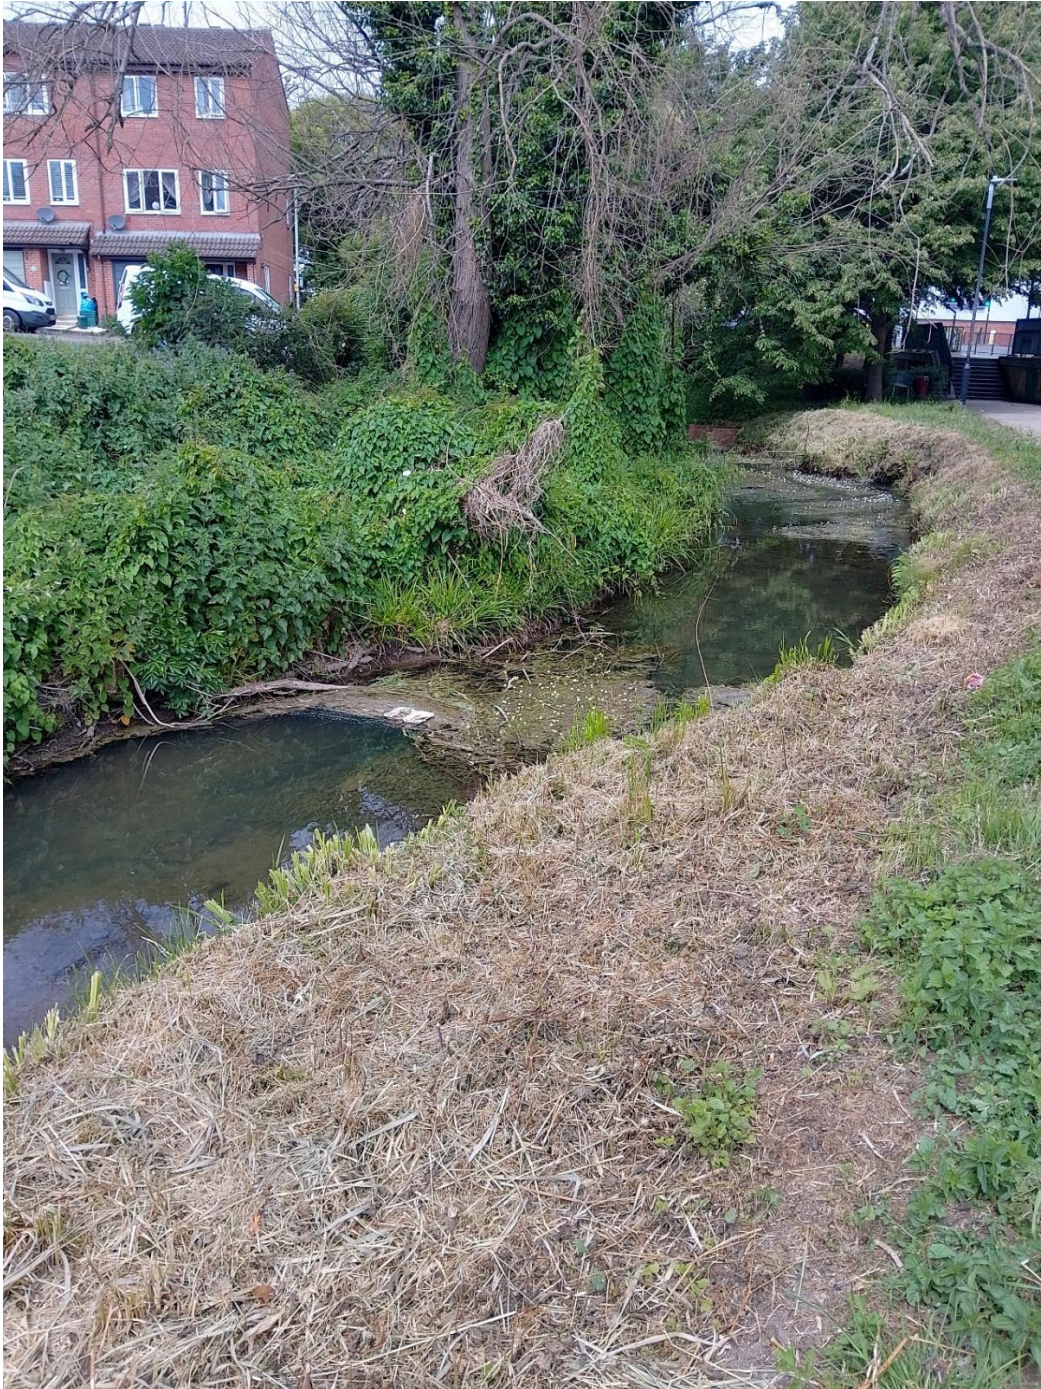
*Photo 22 The end of the section of Chelt reviewed at Gloucester Road. The end of the channel that can be seen in the middle distance becomes quite constrained and a small brick wall interacts with the channel. This should be reviewed to avoid any influence on flood water being backed up by the constraint here.*

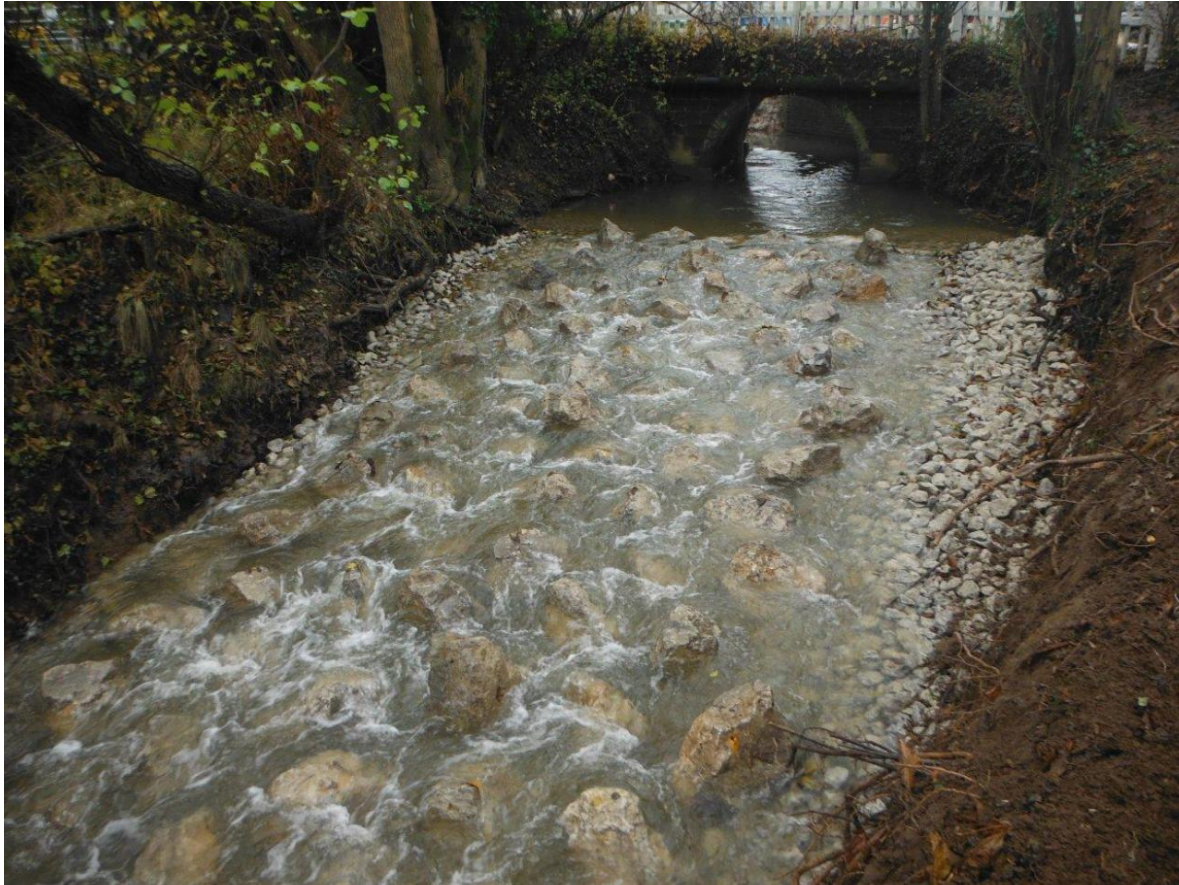
*Figure 7 Example of a rock ramp. It could be possible for the concrete in the overflow channel between Honeybourne Way and the weir to be chopped out, reformed and a rock ramp installed across the gradient between the Chelt downstream on the road culvert – buried underground service cables and pipes allowing. Alternatively, a technical fish pass could be investigated, but these are very expensive to install and need maintenance. Baffles at the entrance to the culvert may be required to maintain water depths and velocities to enable fish passage. It may be a variation on this solution could be used at the top of the overflow channel to get fish up to the Waitrose car park culvert.*

- The most feasible option for fish passage at the massive barriers around Waitrose car park would be to create a route through the overflow channel. This would involve adapting the weir at the downstream end (Figure 7), ensuring passage conditions in the culvert under Honeybourne Way, adapting the grill and offtake into the overflow channel just downstream of Waitrose and adapting the culvert under the car park, below.

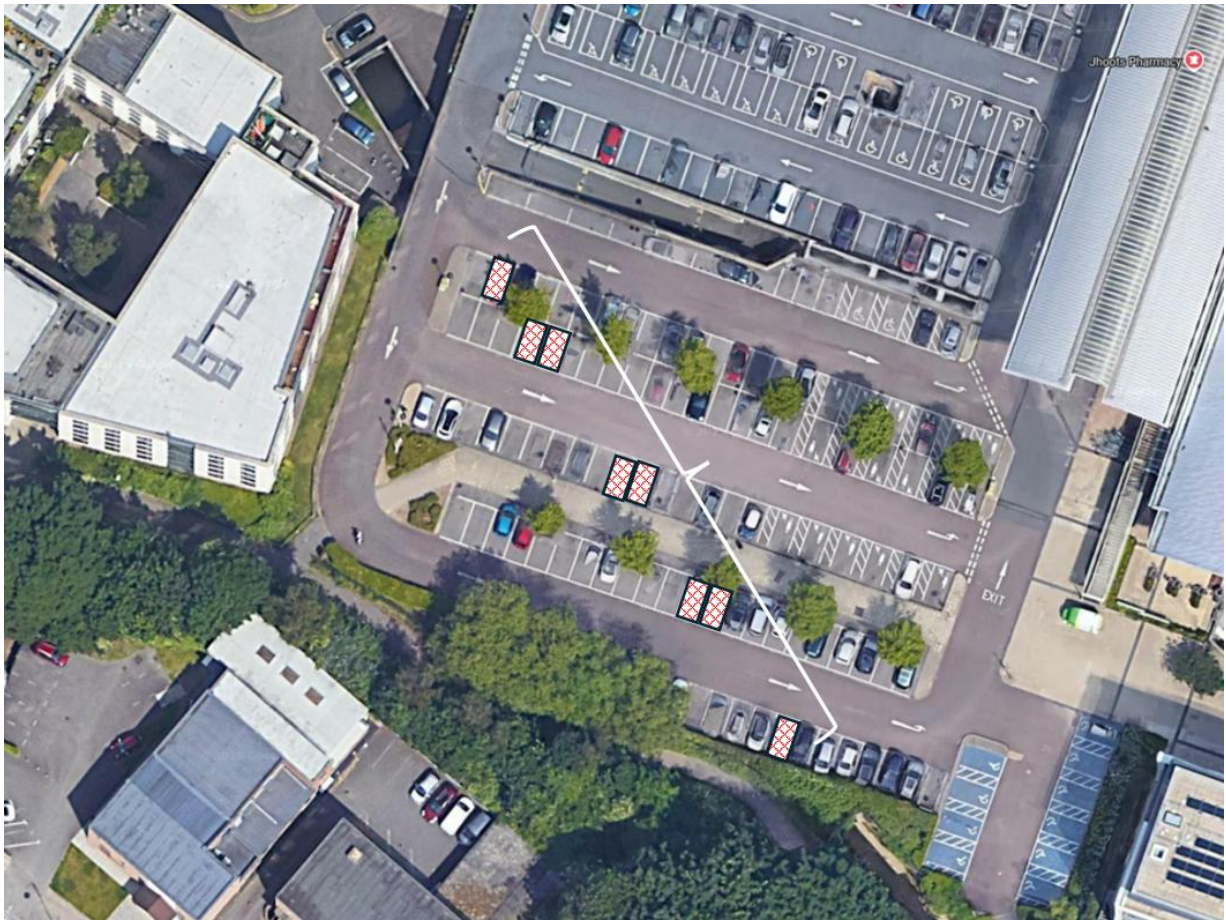
Figure 8 A potential concept for letting light into the culvert below the Waitrose carpark; replacing car parking spots with a solid steel grate (

highlighted by the white bracket). This should allow light through while retaining car parking capacity. It may be possible to install some sets of baffles in the culvert, by engaging with the engineering team responsible for maintenance of the channel asset.

- One option for improving fish passage at Waitrose car park is cutting out discreet sections of carpark over the Chelt and replacing with solid grating to allow some light down to the channel. Locating these at up to eight car parking spots as per (Figure 8) may be a viable approach. Additional approaches to managing flow and water levels through the culvert should be considered with a fish passage specialist (e.g. feasibility of baffles, location and installation).

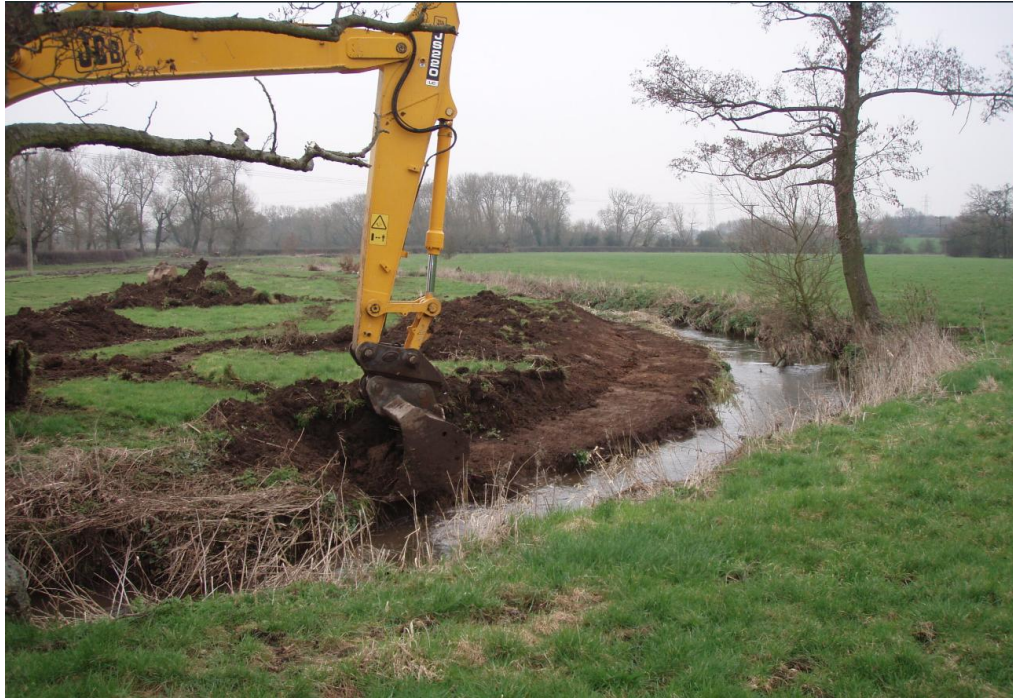
*Figure 9 Pulling banks back will provide space for the water course and more flood water capacity, whilst easing impacts of high velocity flows.*

- Consider lowering or regrading of the riverbanks through the green spaces to allow for more space for the river to develop and improve flood water capacity and flooding resilience.

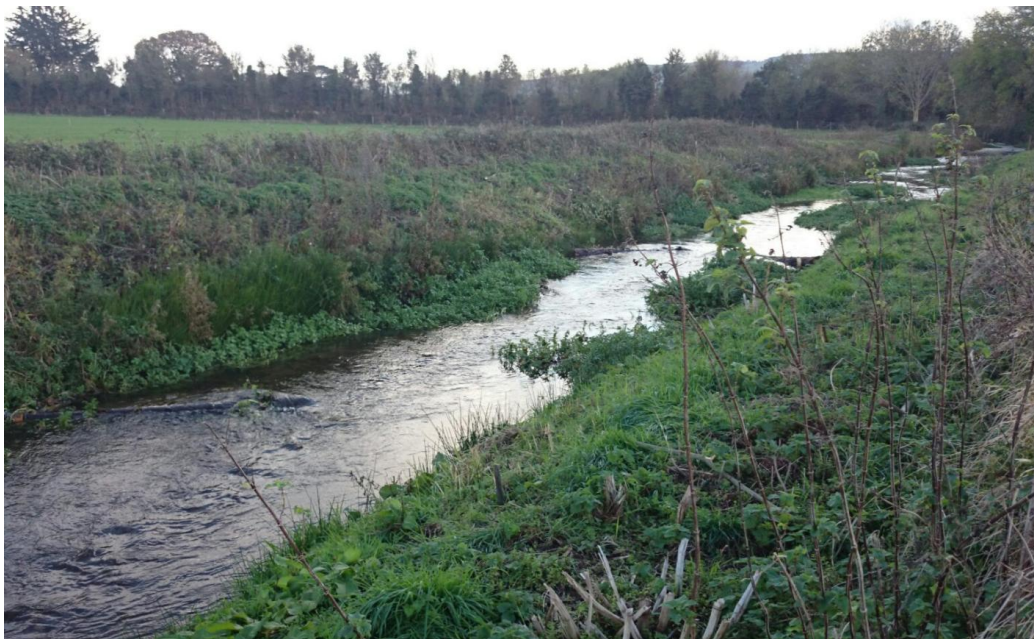
*Figure 10 Regraded banks alongside modified channels allow natural river features and marginal plant growth to develop , without impacting flood water conveyance capacity. . In conjunction with a modelled suite of catchment wide flood resilience interventions, it may be possible to consider actions such as this on the Chelt, allowing nature to return at the same time.*
